FIRE CRACK FAILURE OF A DUCTILE CAST IRON ROLL

ABSTRACT

This paper reports the failure analysis of fire crack of a ductile iron roll in a hot rolling mill in Medan, Indonesia. The roll failed prematurely after only 3,500 tons of service instead of the normal service life of about 65,000-70,000 tons. Standard procedures for failure analysis were employed in the investigation. It was found that the failure of the roll was due to excessive heat. Then it led to causing numerous fire cracks being created very high stress resulting from inadequate water cooling of the roll. Heat cracks around the fracture surface were clearly visible. It was, therefore, concluded that the root cause of the failure is inadequate designs of the roll and associated equipment. Alternative designs are suggested to prevent or minimize similar failures in the future, and to avoid the losses resulting from such failures.

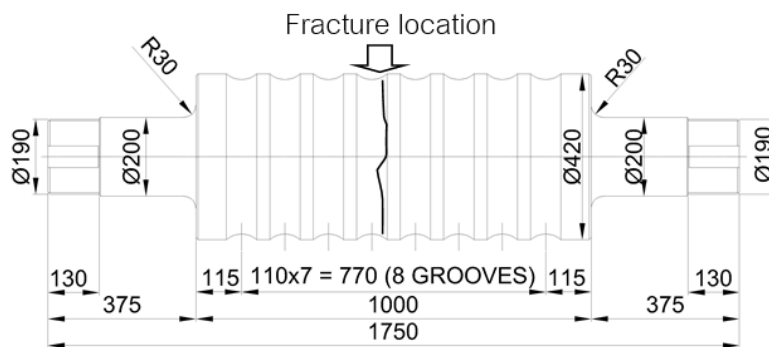
The failed roll was used at an intermediate rolling stand in a continuous hot rolling steel rebar mill in Medan, Indonesia. The roll failed after it was used for rolling approximately 3,500 tons of steel. Normally, the service life of this type of roll is much longer and can be used for rolling up to 65,000-70,000 tons of steel. The mill produced reinforced concrete steel re-bar sized 6 to 22 mm diameter with the reheating furnace capacity of 30 tons/hr. It was designed for rolling steel billets with cross-sectional areas of 45 X 45 mm² square and 82 X 35 mm² oval. The rolling temperature of this rolling stand was approximately 1,000 °C. Nominal dimensions (mm) of the failed roll and fracture point are shown in Figure 1. Chemical compositions of the roll material are shown in Table 1.

Figure 1 Nominal dimensions and fracture location of the failed roll

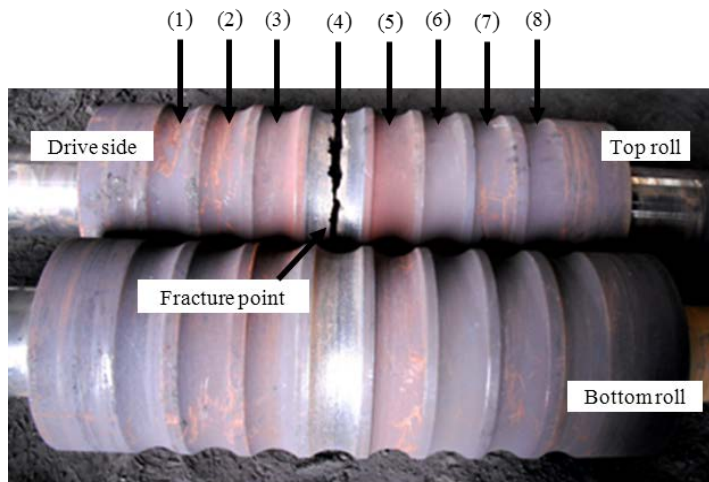
A general appearance of the failed roll is as shown in Figure 2. The failed roll was taken out from the rolling stand and examined visually. The fracture occurred at the 4th groove from drive side of the top roll. The fracture surfaces were slightly flat as shown in Figure 3. The presence of oxides (dark) at the periphery of the fracture surfaces, approximate 10 mm, is readily apparent, as shown in Figure 4. The fire cracks, on oval grooves, were observed on the top and the bottom rolls.

Figure 2 Roll design, oval groove distribution, and position of fracture point

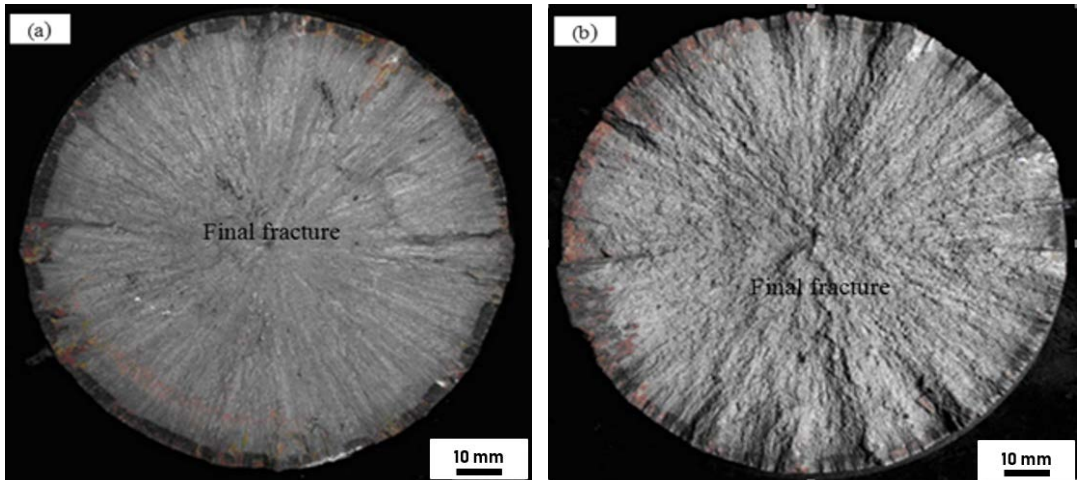
Figure 3 Fracture surfaces of the failed roll (a) drive side (b) top side

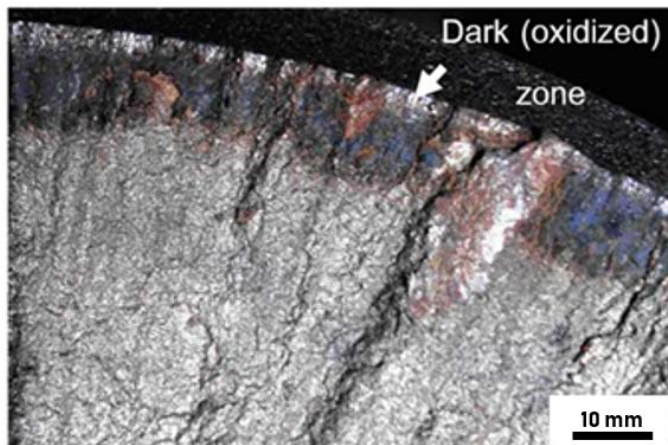
Figure 4 Magnified view of fracture surface

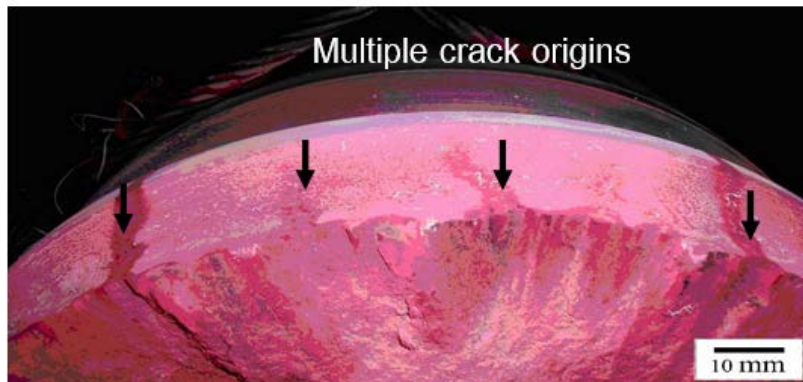
The crack initiations occurred at the surface of oval groove as shown in Figure 5. Numerous fire cracks were observed in the vicinity of the fracture surfaces and surface of oval groove of bottom roll as shown in Figure 6. It can be initially indicated that the failure of the roll occurred due to the fire cracks which subsequently formed a larger crack leading to final failure. From the observation of the groove surface of the rolls, both the top and the bottom rolls occurred the network of fire cracks on the surface of the oval groove as shown in Figure 6, which is indicated both rolls water cooling from supply not enough.

Figure 5 Fracture surface of the crack origins

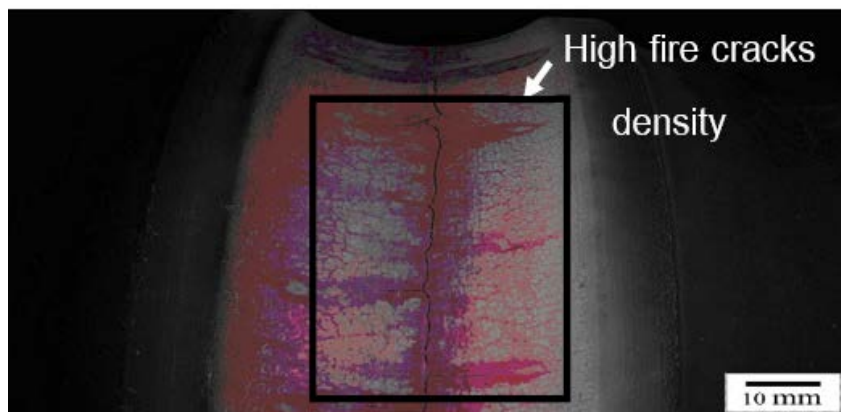
Figure 6 High fire cracks density on oval groove of the bottom roll

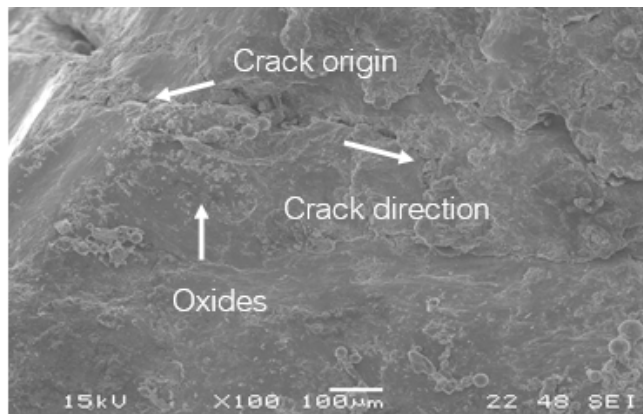
The specimen of fracture surface of the failed roll, which is shown in Figure 7 was examined by SEM in order to look more closely at the nature of the fracture. The cracks and oxides were also found in the fracture surface which can be seen in Figure 8. The crack started at the periphery of the oval groove of the roll and then it moved inward to the center of the roll. The oxides, which cover the crack originated surface, was observed. It can be seen that the fracture surface in Figure 8 shows the decohesion surface is rather flat, as shown in Figure 9. Moreover, although the fracture surface is essentially brittle. Figure 9 is, however, primarily brittle (cleavage) and show manifestations of cracking and cleavage steps.

Figure 8 Fractography showing view of the crack origin and oxides

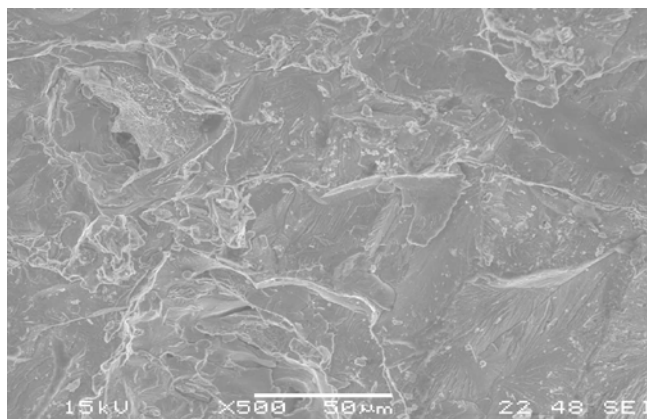
Figure 9 Morphology of brittle features and small ductile zone

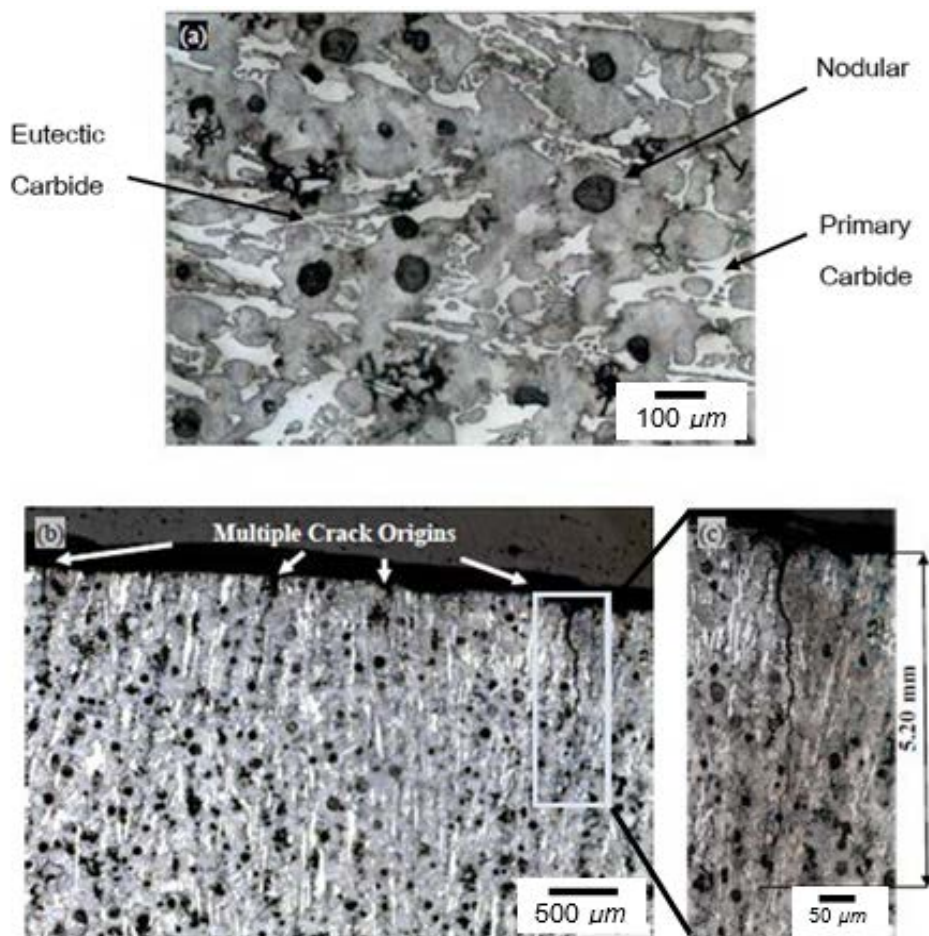
The microstructure consists of nodular graphite and eutectic carbide in pearlite matrix as shown in Figure 10a, typical for ductile cast iron rolls [10]. Multiple cracks were also found on outer shell of roll as can be seen in Figure 10b. These cracks appeared as started at the periphery of the outer shell of the roll and moved inward to the center. Higher magnification micrograph of one of these cracks and crack depth approximately 5.20 mm is shown in Figure 10c.

Figure 10 Microstructure of the failed roll: a) nodular graphite in structure, b) microstructure with multiple cracks, and c) higher magnification morphology of a crack depth (Etched with 2% nital)

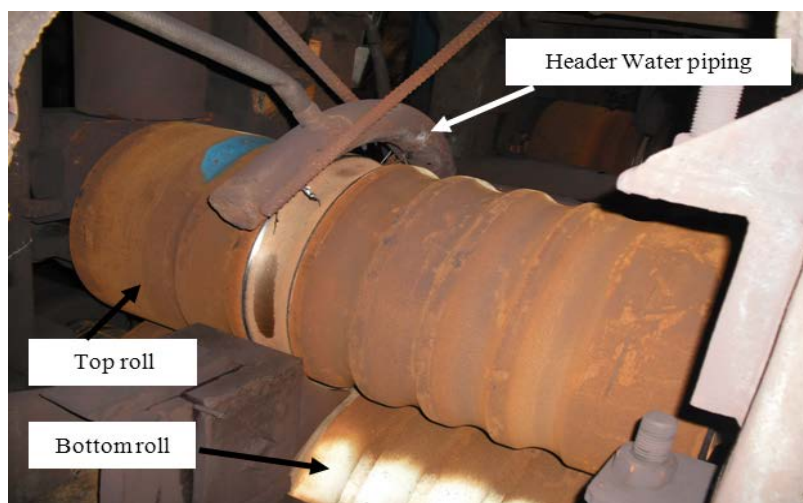
The cooling system for the rolls in this particular mill will be shown in Figure 11. Cooling water was pumped through a steel piping and plastic hose. The control system of water for cooling individual rolls was accomplished by gate valves. Header water piping for roll cooling was installed only at the top of top roll, which means the exit side did not have the water piping. Such design of the cooling system is rather fragile because there was not any warning where things started to go wrong.

Figure 11 Existing roll cooling system

3) Inadequacy in roll water cooling result partly from inadequate design of the roll cooling system.

4) It can be recommended that a robust roll cooling should be redesigned to replace the current one. Header water piping must be moved close to the exit bars where can be guaranteed that the maximum possible temperature will never be critical. Furthermore, the devices, which control water flow rate as same between top and bottom roll, must be added. When such parameters are out of the set values, the system should warn the operator. The recommended design is as shown in Figure 12.

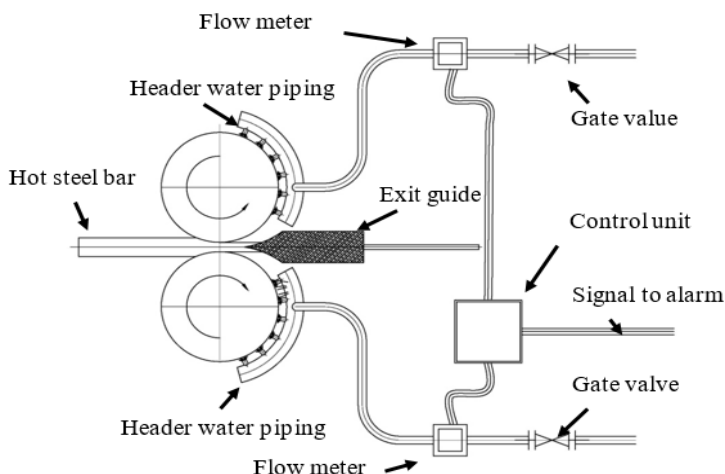
Figure 12 Roll cooling system with sensor devices
